Manhole Inspection Summary

Manhole # S290__052MH

Location Address: **BEHIND 820 W CROSS ST**

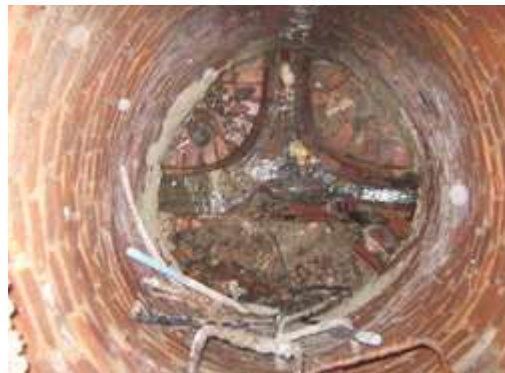
Top View

frame offset; infiltration from chimney joint
& from frame

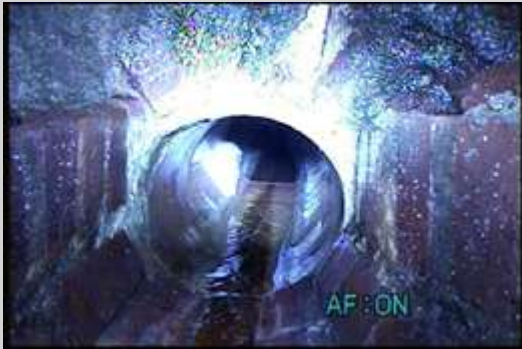
12 O'Clock Outflow

8 in. Circular Gravity Sewer
Pipe Out @ 12 O'Clock

Pipe Height: **8.4** (in.) Rod and Bar (Angled)
Pipe Material: **Clay** ☐ Pipe Lined
Invert Depth: **8.84** (ft.) Flow Characteristics: **Slow**
Deposits: ☒ None ☐ Mud ☐ Sludge ☐ Debris ☐ Grease
Silt Depth: **0** (in.) Deposits Extent:
Infiltration: **None** Pipe Seal Cond: **Sound**

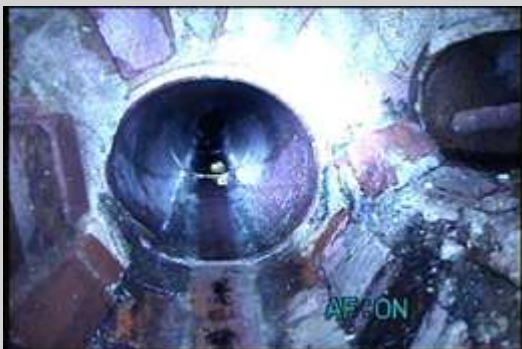
3 O'Clock Inflow

8 in. Circular Gravity Sewer
Pipe In @ 3 O'Clock

Pipe Height: **8.4** (in.) Rod and Bar (Angled)
Pipe Material: **Clay** ☐ Pipe Lined
Invert Depth: **8.36** (ft.) Flow Characteristics: **Slow**
Deposits: ☒ None ☐ Mud ☐ Sludge ☐ Debris ☐ Grease
Silt Depth: **0** (in.) Deposits Extent:
Infiltration: **None** Pipe Seal Cond: **Sound**

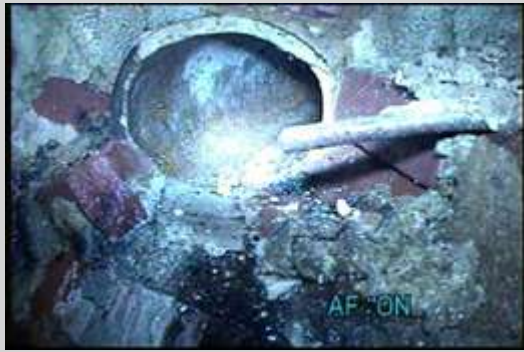
4 O'Clock Inflow

6 in. Circular Gravity Sewer

Pipe In @ 4 O'Clock

Pipe Height: **6** (in.) Rod and Bar (Angled)

Infiltration: **None**

Pipe Seal Cond: **Sound**

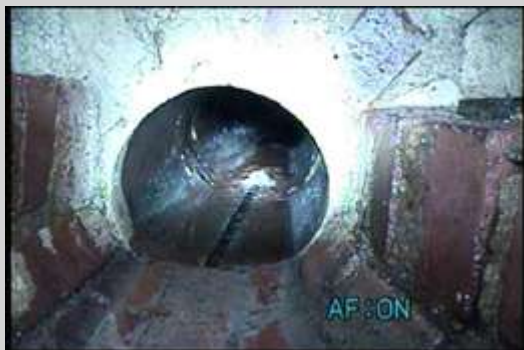
9 O'Clock Inflow

8 in. Circular Gravity Sewer

Pipe In @ 9 O'Clock

Pipe Height: **8.4** (in.) Rod and Bar (Angled)

Infiltration: **None**
